# Manhole Inspection Summary

Manhole # S43SS\_032MH

**Location** Address: **1600 MONTPELIER ST** Cross Street: **KENNEDY AVE**

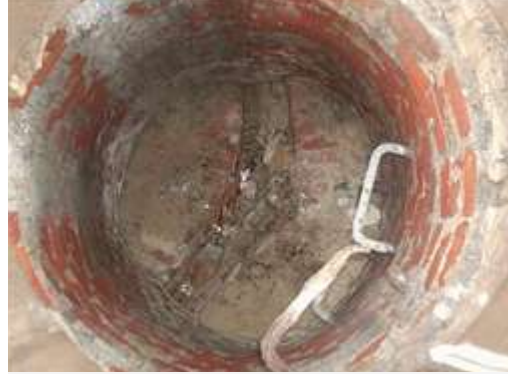
Top View

Corroded steps. Evidence of surcharge - Bench debris. Channel debris.

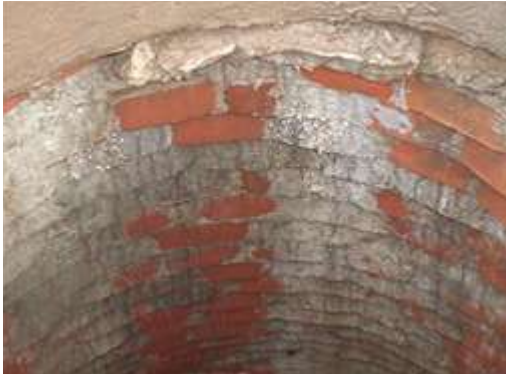
Defect

Frame leaks. Adjustment deterioration and infiltration.

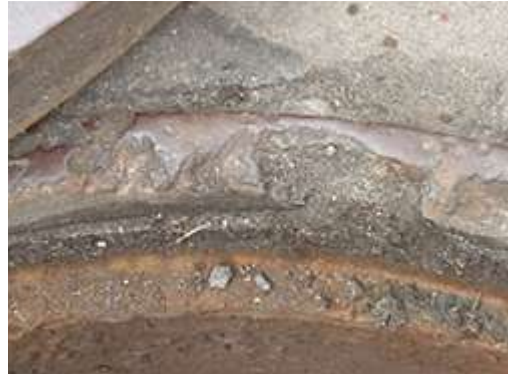
Defect

chipped frame

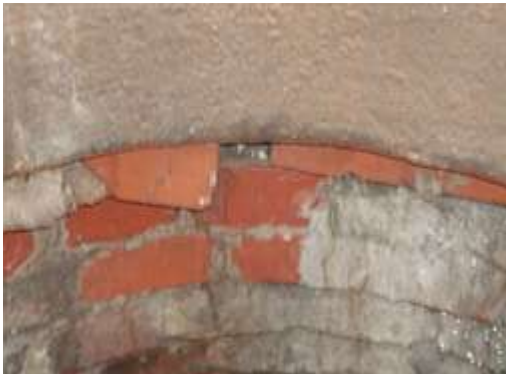
Defect

Frame leaks. Adjustment deterioration and infiltration.

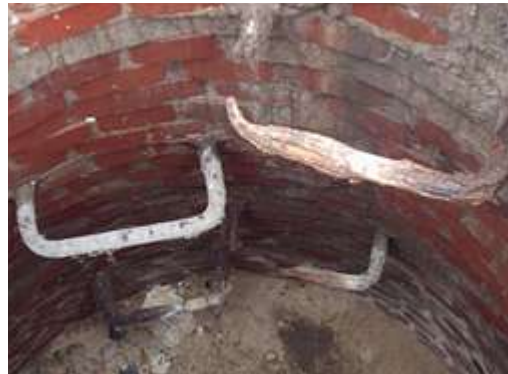
Defect

Corbel and Barrel infiltration.

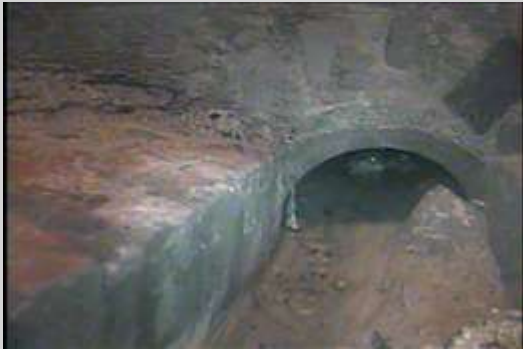
### 8 in. Circular Gravity Sewer Pipe Out @ 12 O'Clock

Invert Depth: **8.19** (ft.) Flow Characteristics: **Slow**

Deposits: ☐ None ☒ **Mud** ☐ Sludge ☒ **Debris** ☐ Grease

Silt Depth: **4** (in.) Deposits Extent: **Heavy**

Infiltration: **Evidence** Pipe Seal Cond: **Unknown**

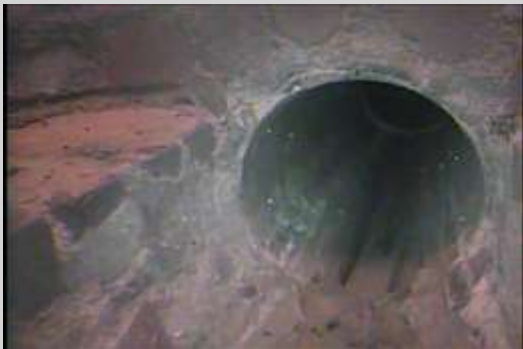
### 8 in. Circular Gravity Sewer Pipe In @ 8 O'Clock

Invert Depth: **7.79** (ft.) Flow Characteristics: **Slow**

Infiltration: **Evidence** Pipe Seal Cond: **Unknown**
